# Radisson Phuket Mai Khao Beach Construction Report

Report Number: 010 August 2020

Radisson Phuket Mai Khao Beach Construction Progress Report

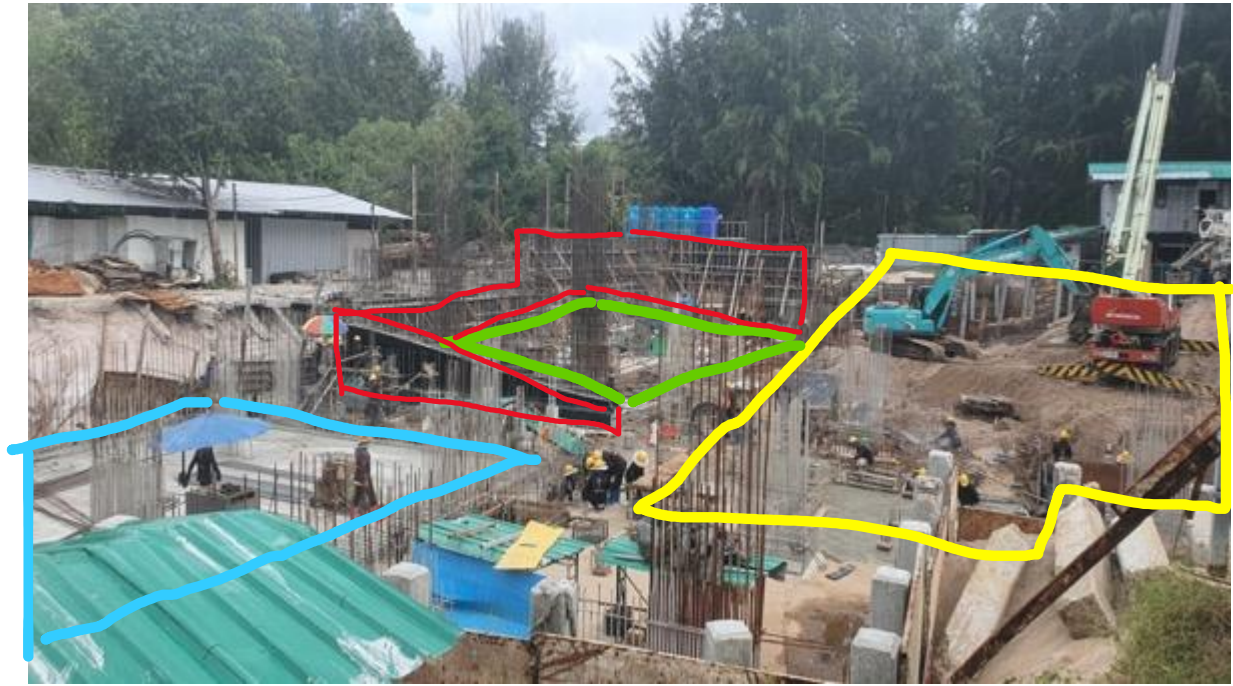
**Building 7 & 8 Red areas Retaining walls at rear of prep kitchen /canteen.  
Green Areas Slab of Building 7 & 8. Yellow front area of building 7&8 slab  
area being prepped ready for slab formwork. Blue is slab building 6**

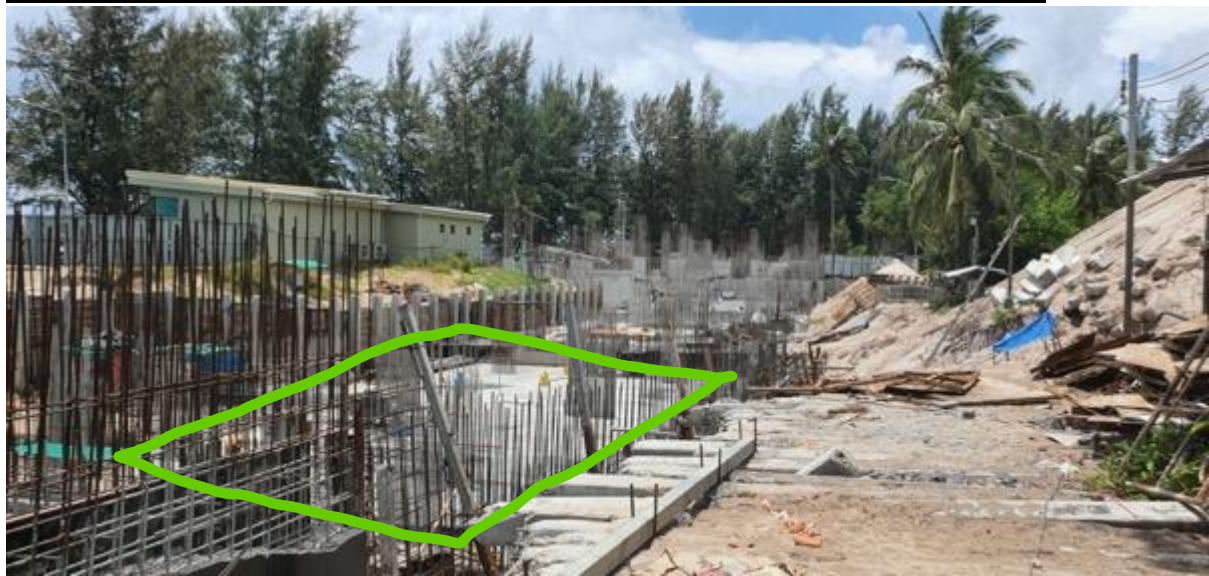
**Slab area transformer and generator room building 6 rear side**

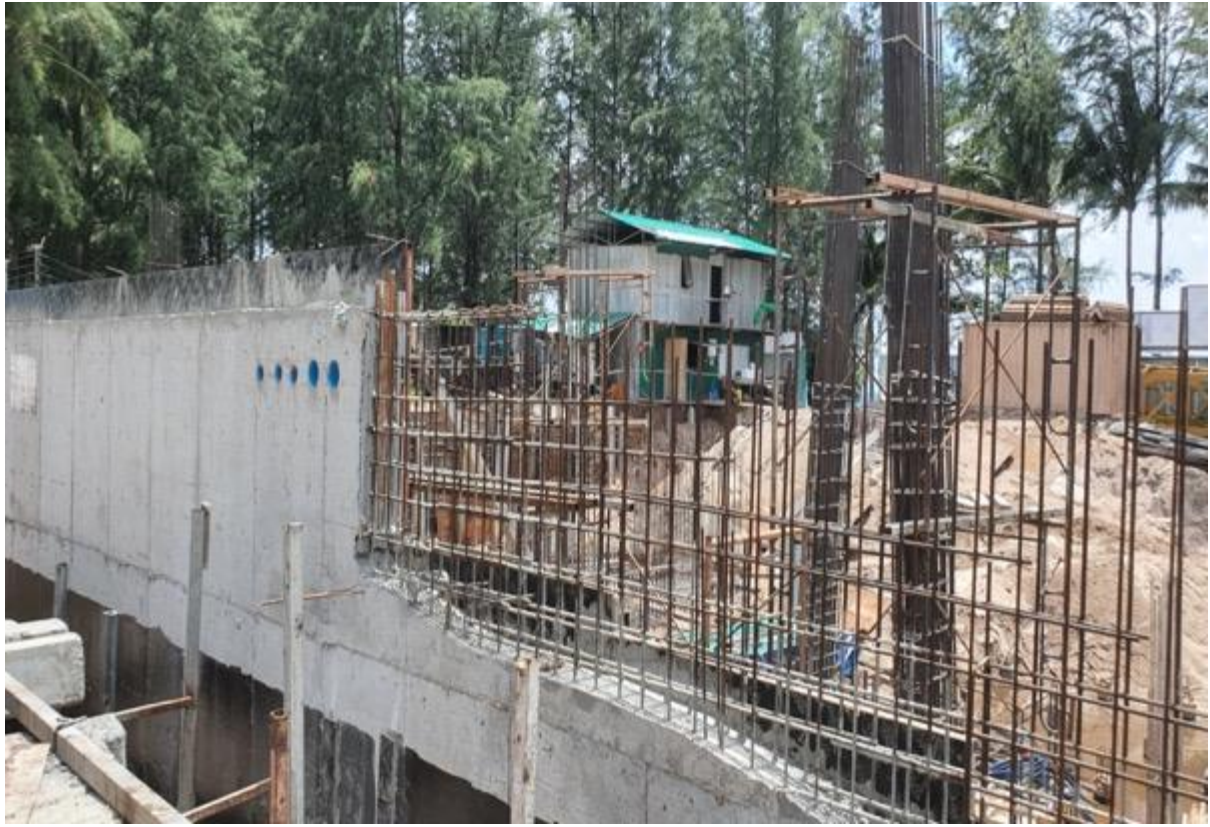
**Retaining wall at rear of building 7 & 8 with waterproof (black) up to access road level – steelwork of columns can be seen in prep kitchen area**

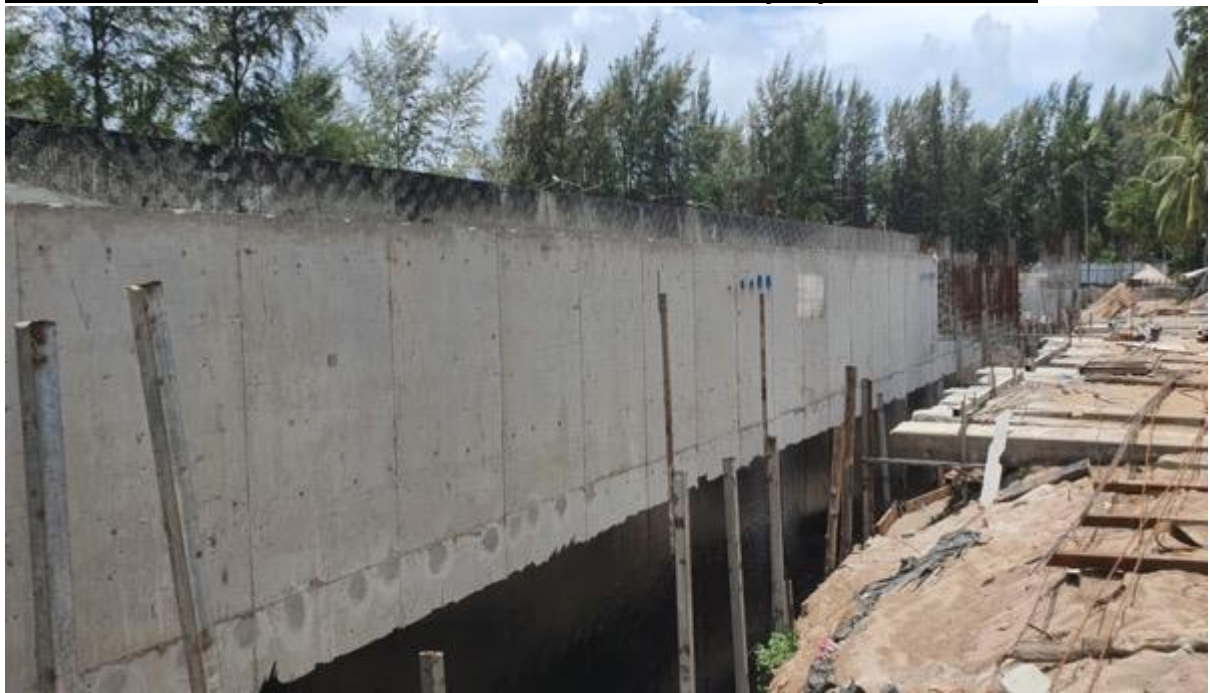
**Retaining wall rear of 7& 8 (scale is wall height is 4M high, again waterproof to road level can be seen being applied to wall, once cured the soil can be backfilled up to the wall**

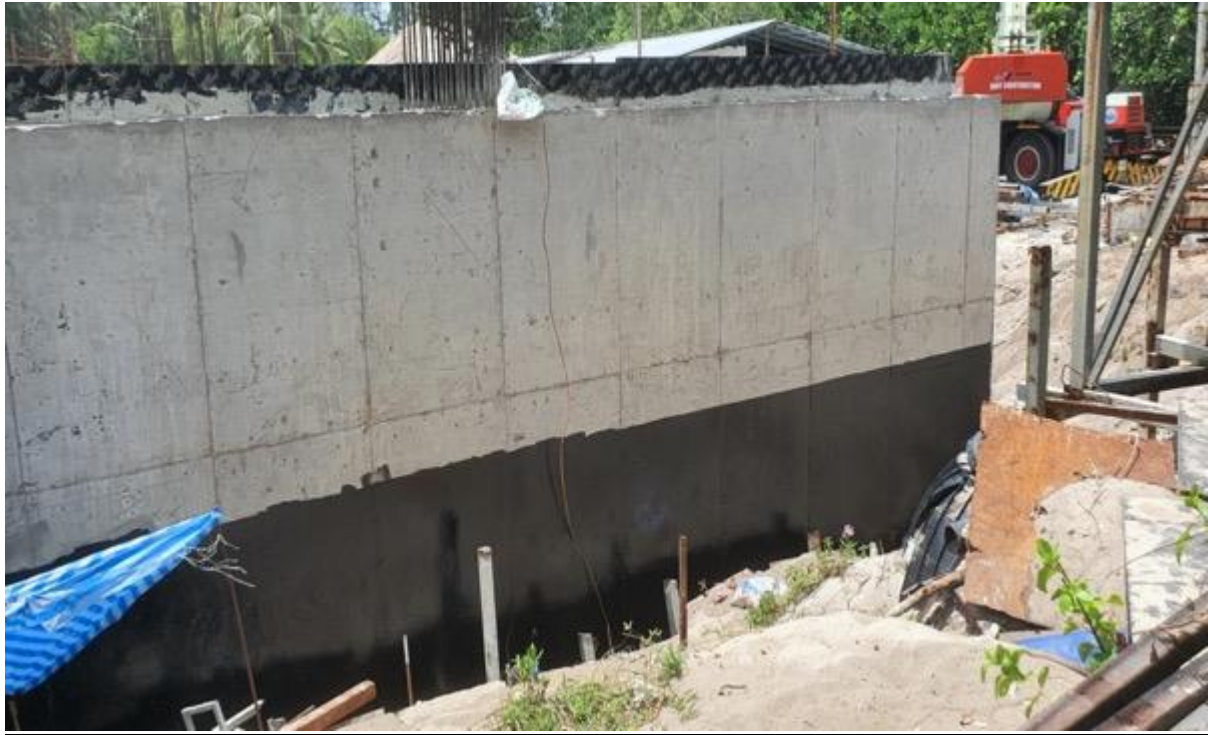
**Retaining wall side of building 8, waterproofing being applied**

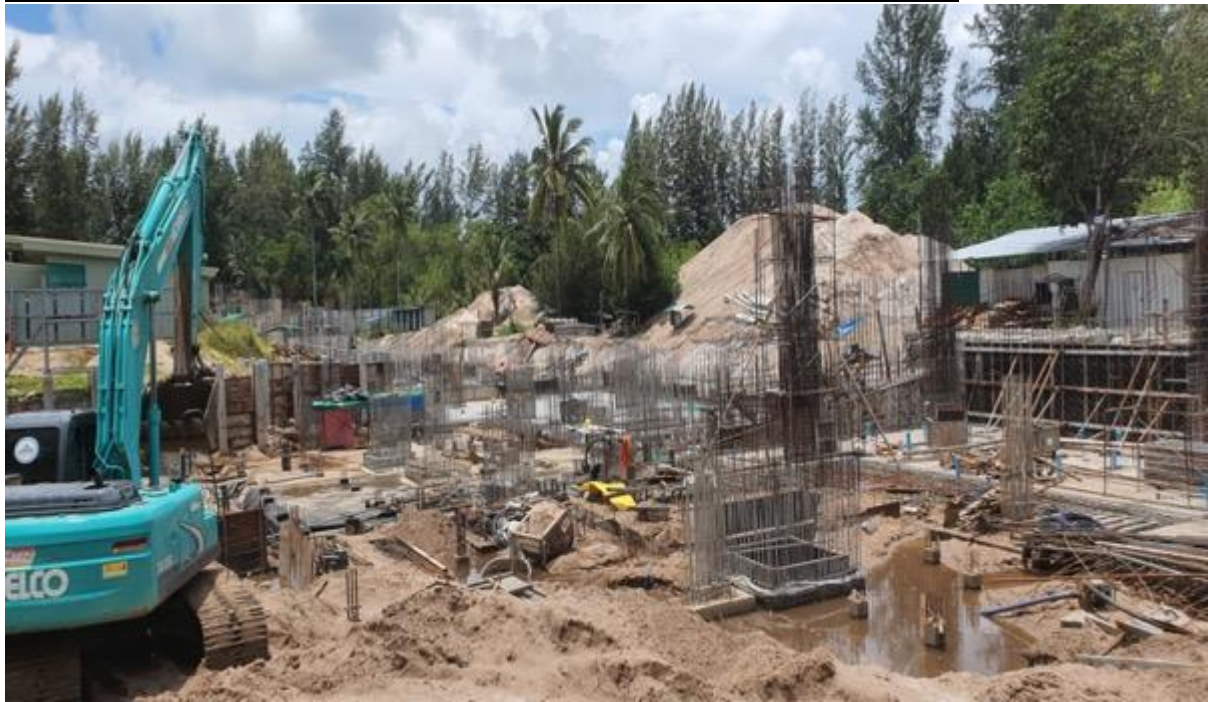
**Preparing area front side of building 7 & 8 Slabs ready for Slab formwork – this is the last small pocket affected by the natural water table as seen in bottom right corner, once this is completed the basement area will be unaffected by groundwater**

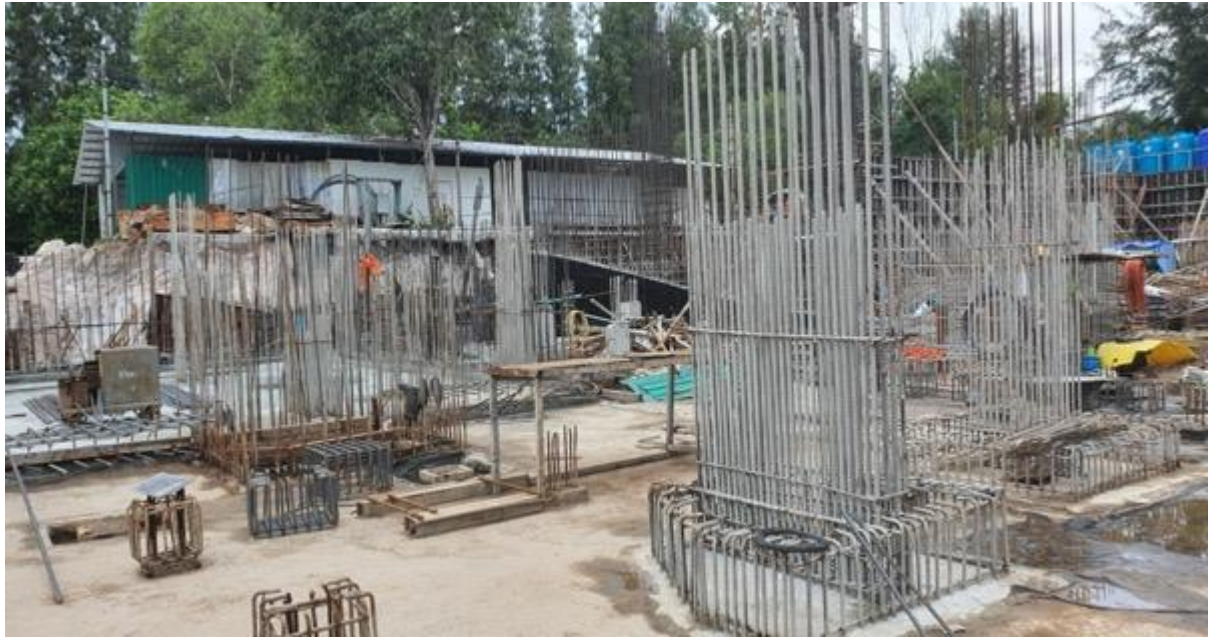
**Lien concrete (area between soil and underside of slab) prepared front side of building 6**

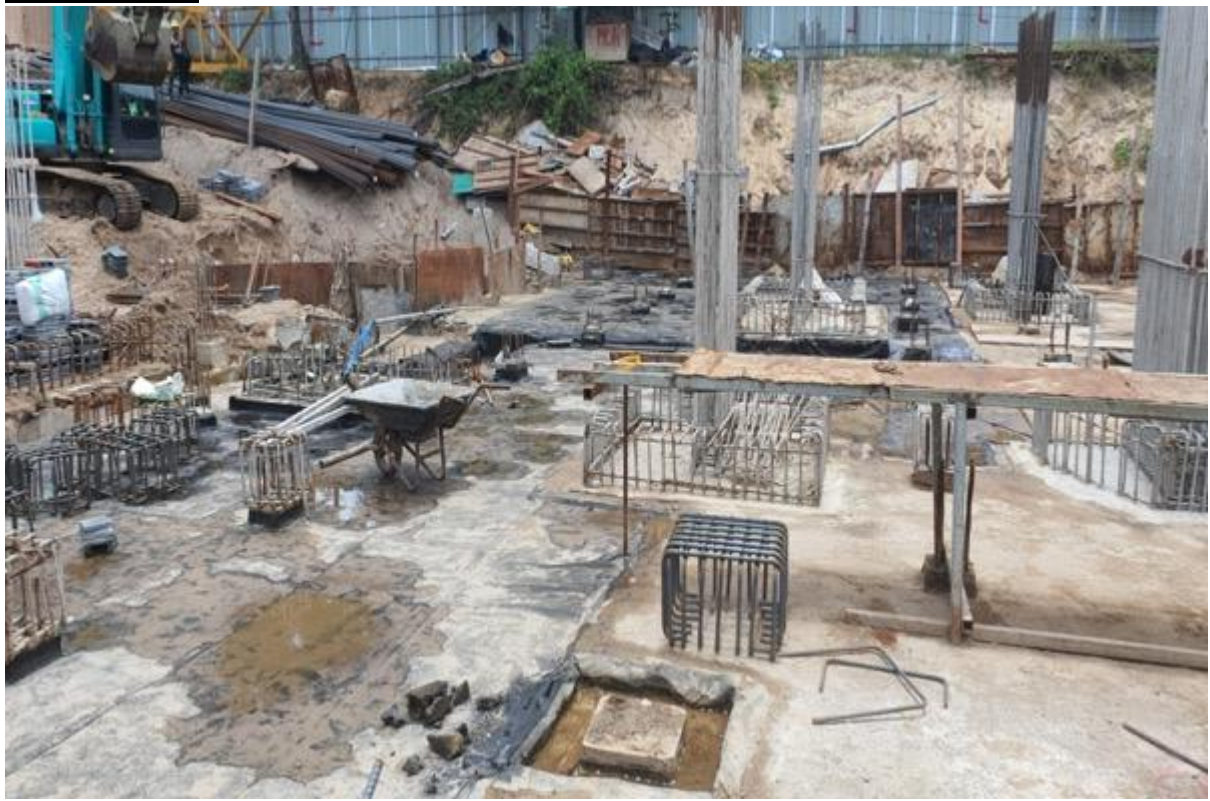
**Lien concrete and waterproof membrane being applied vicinity front side of building 6 /7 once membrane is finished the steelwork for the slab will be laid ready for pouring slab**

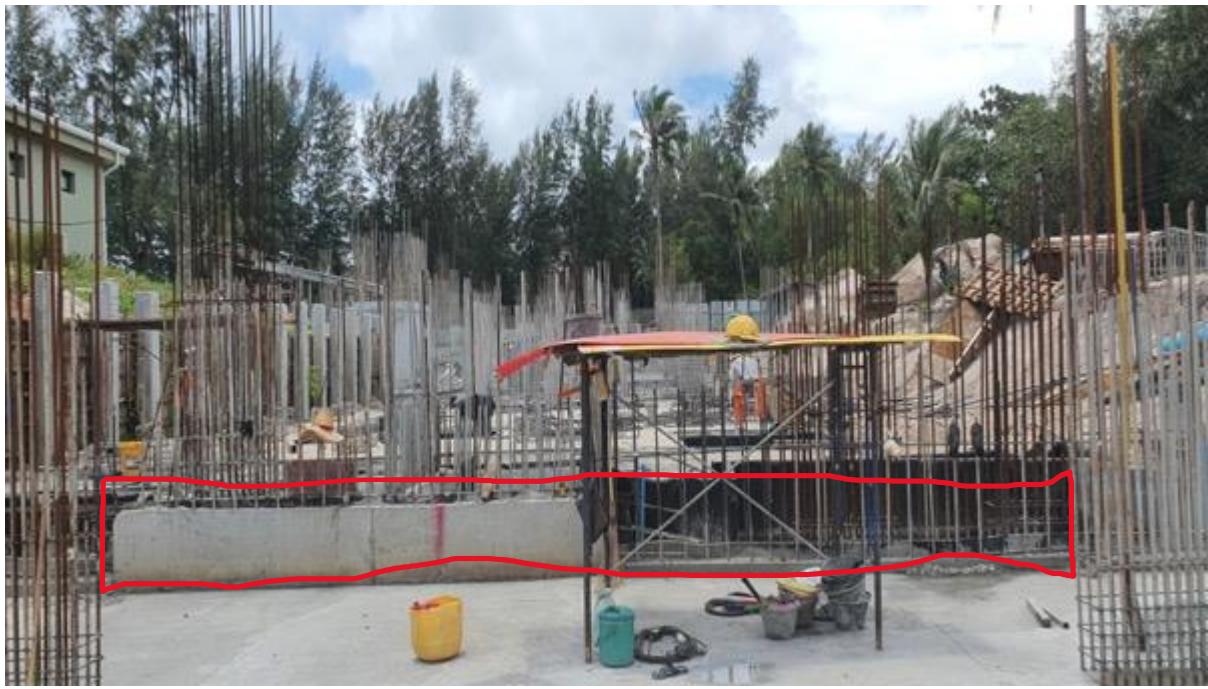
**Slab of Building 6 (generator /transformer area) looking towards building 5 and beyond – note the step (red cloud) as the transformer and generator are at lower level in order to give good overhead clearance and space to this essential equipment**

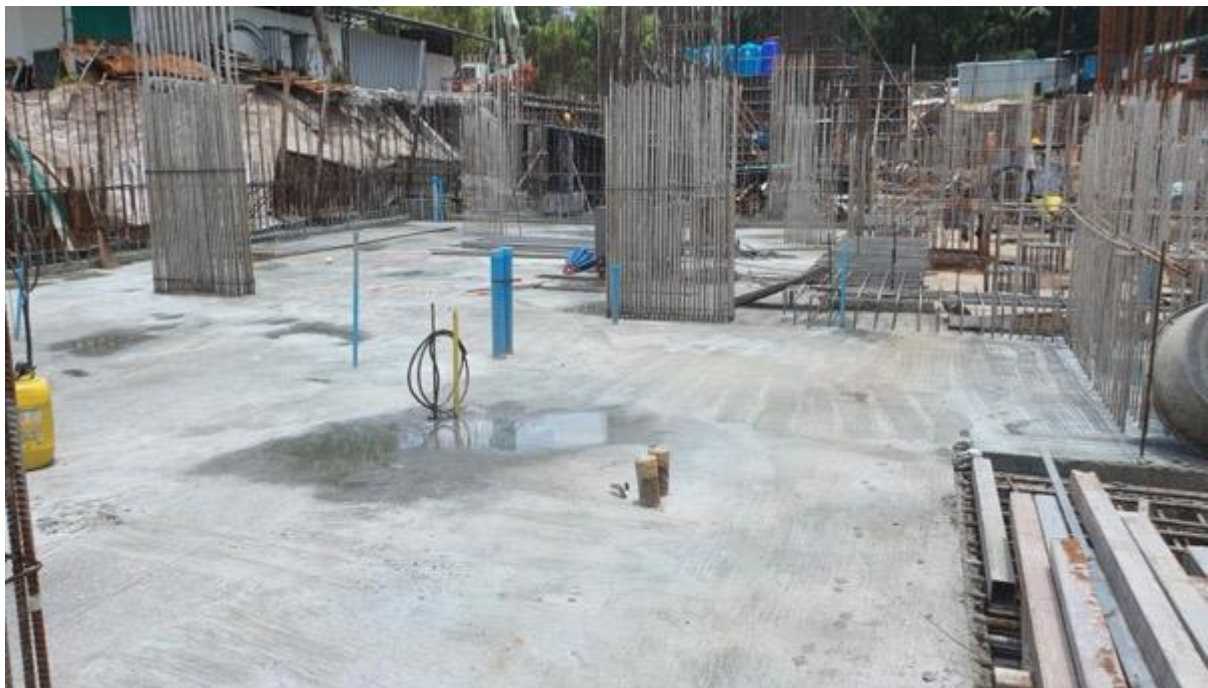
**Slab building 6 generator and transformer general area – looking towards building 7 & 8 area**

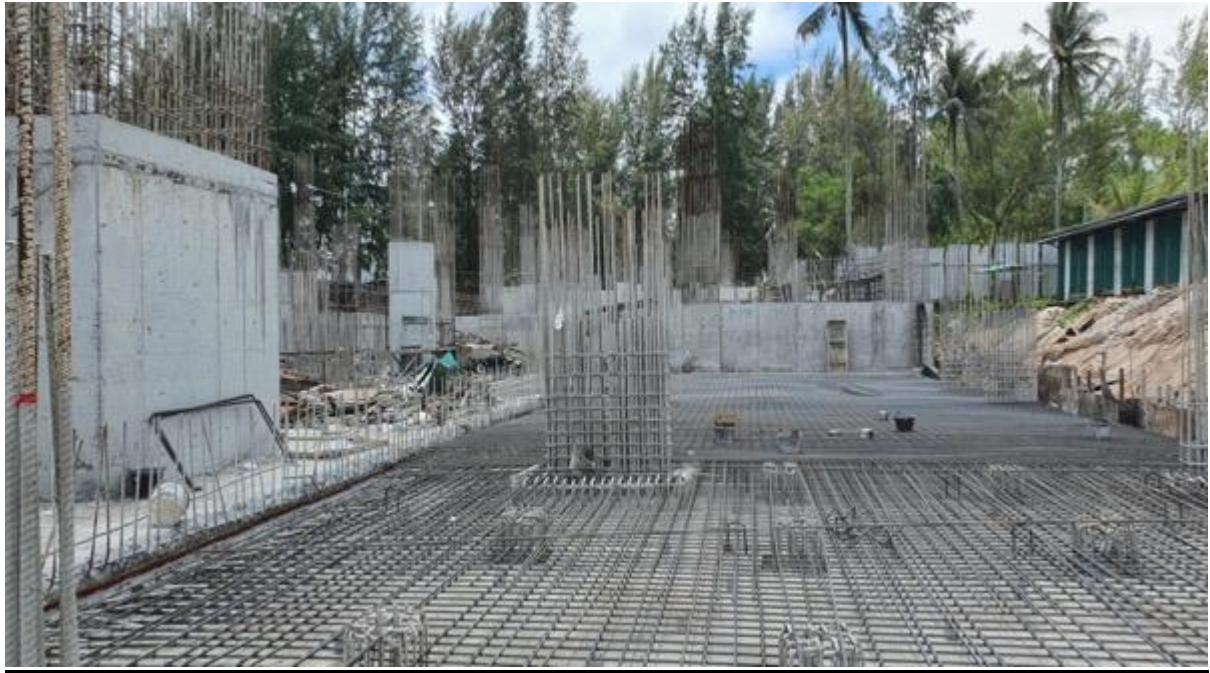
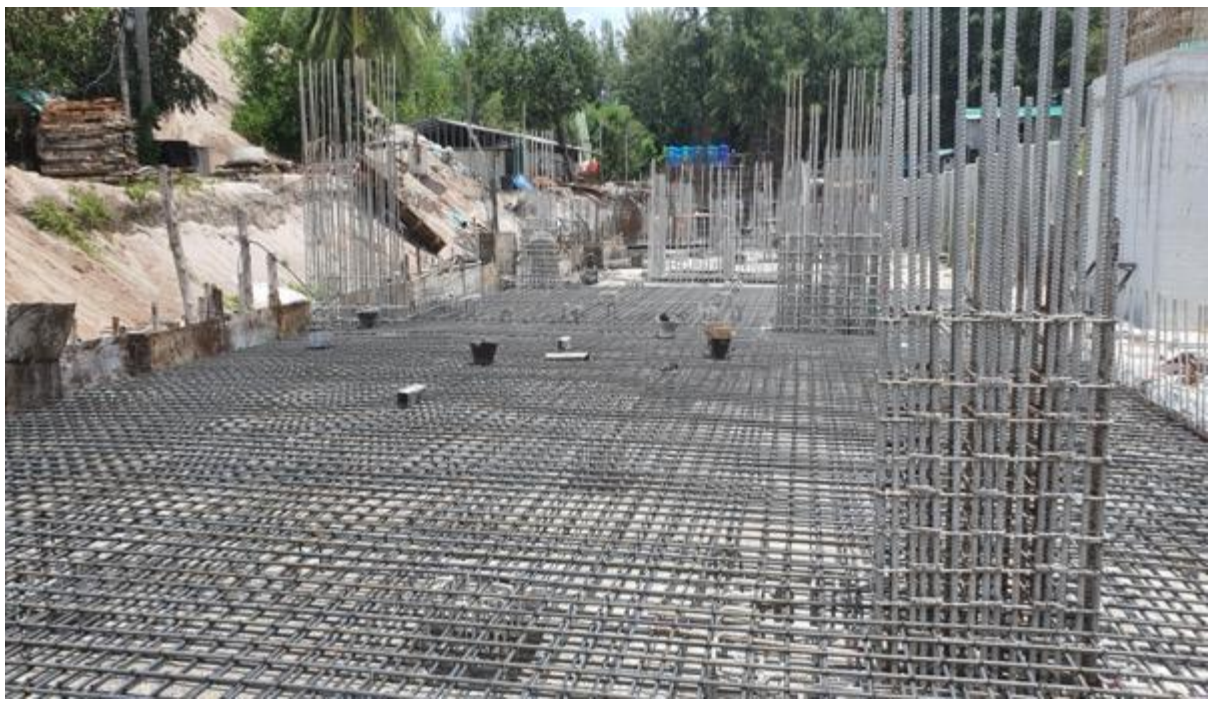
**Steel work ready prior to a pouring of slab general area building 5/6**

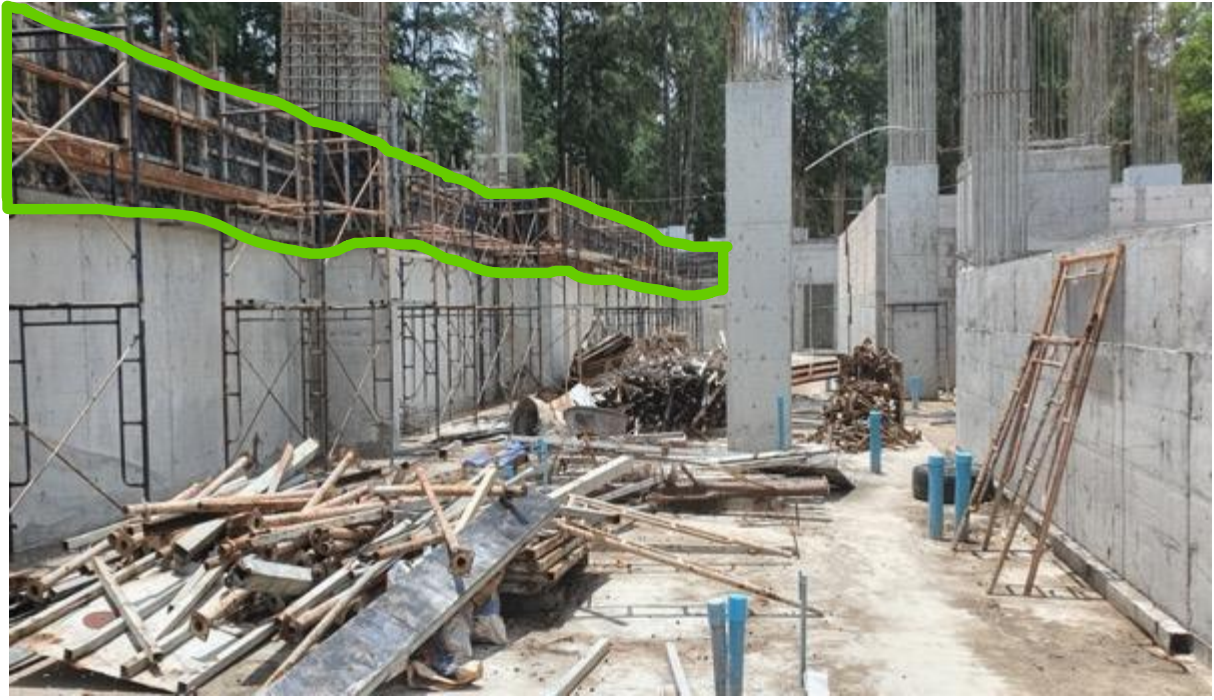
**General area building 3 looking towards 2 and 1 – note columns poured to GF level and green cloud area is formwork retaining wall going up from current level to GF level**

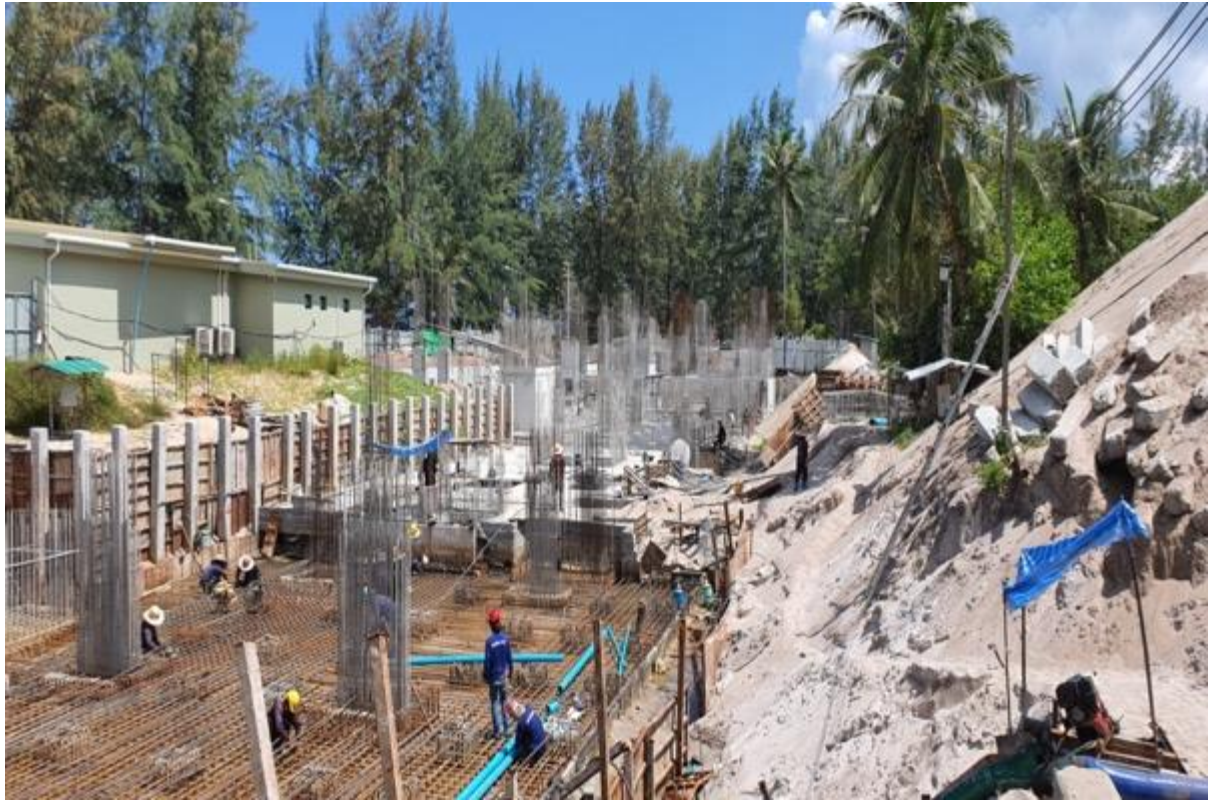
**Slab building 6 being prepared with piping and steelwork**

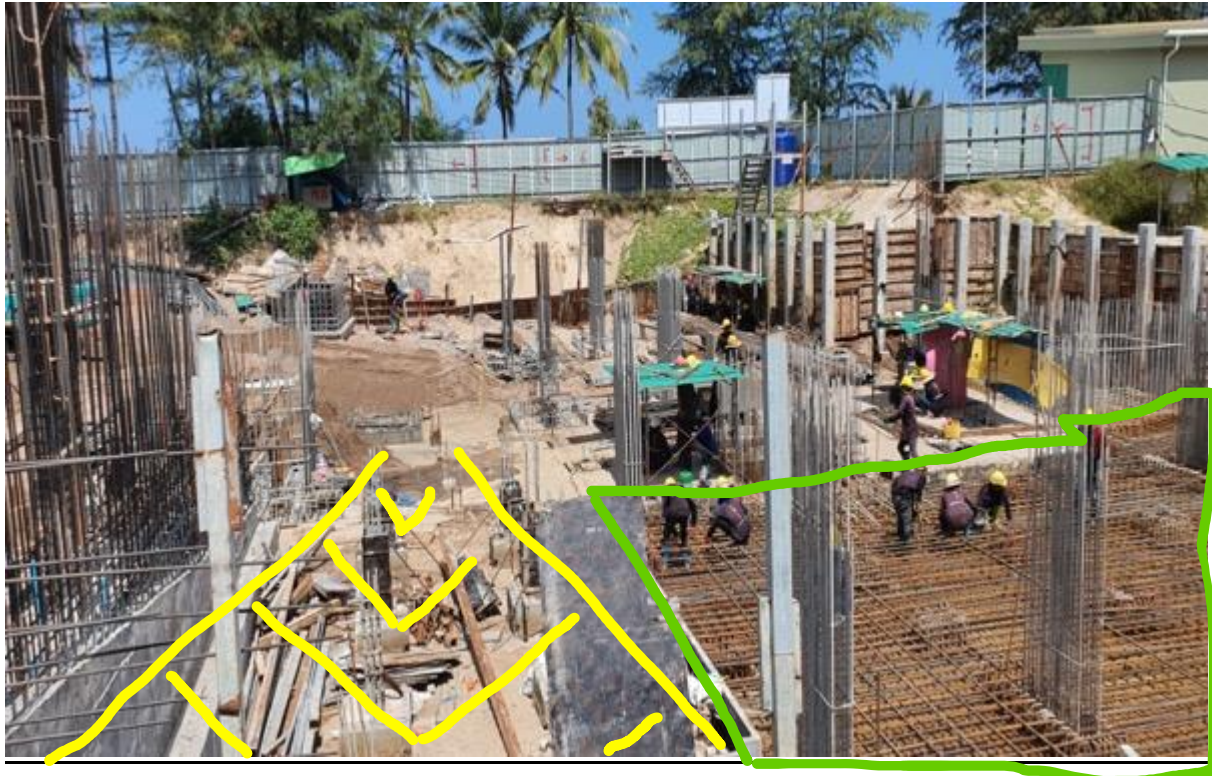
**Preparing slab generator room (green cloud)**

**The yellow area is the ramp area giving entry for vehicles to the basement**

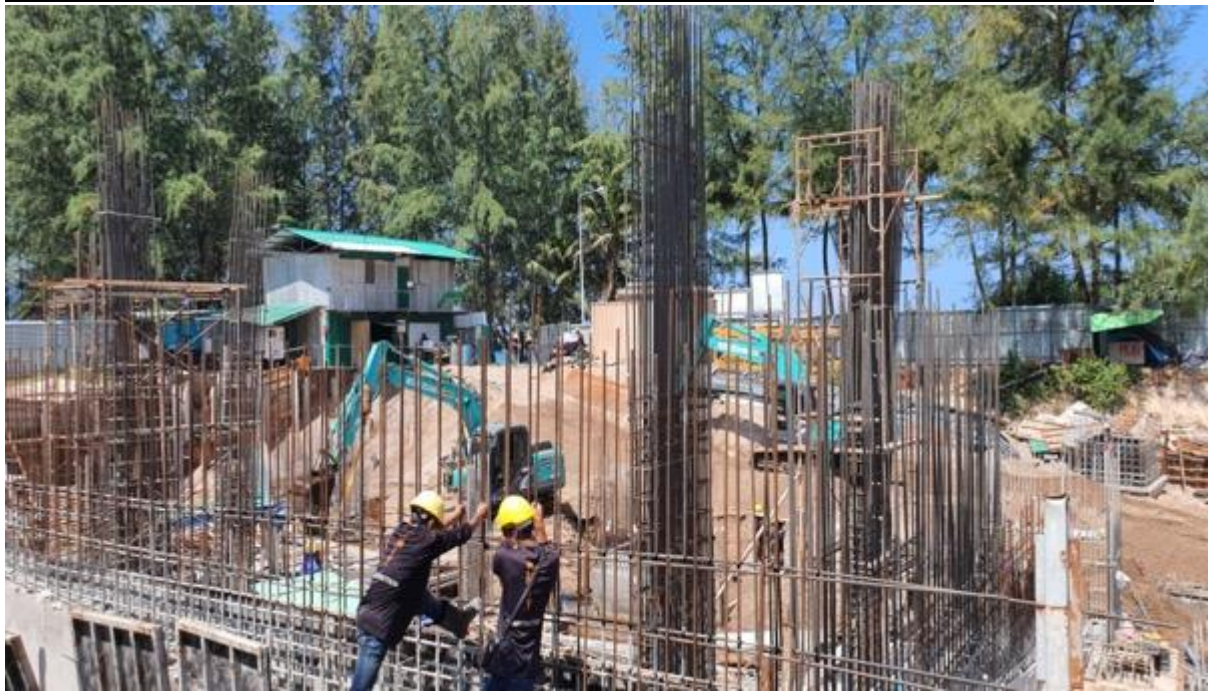
**Removing formwork from the retaining wall in building 7& 8 Zone – rear of prep kitchen and staff canteen**

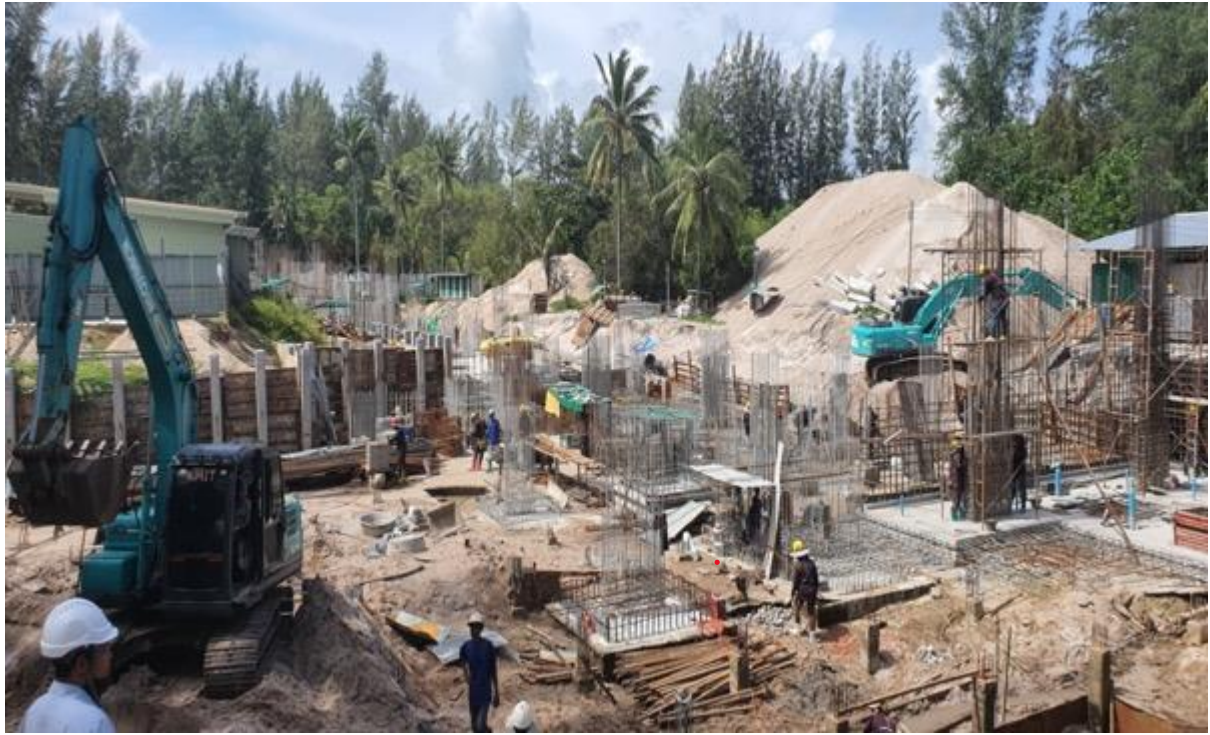
**Ongoing works in region of 6/7/8**

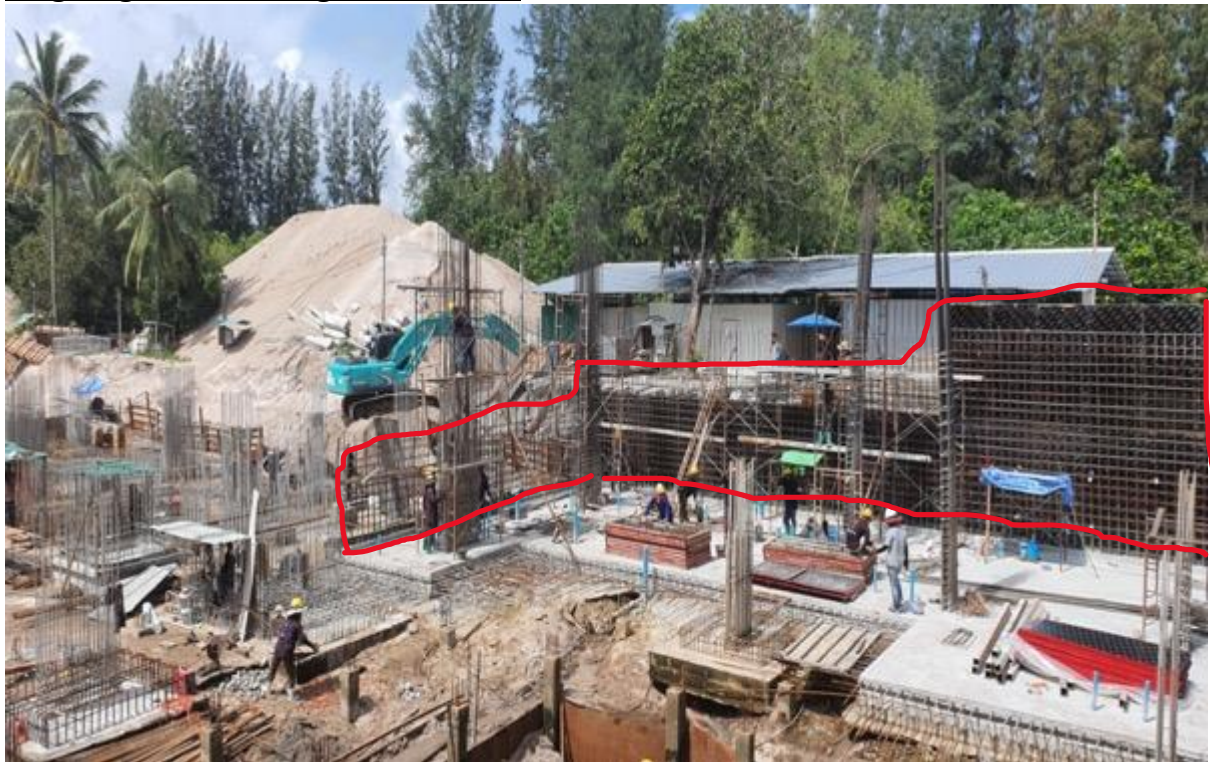
**Preparing retaining walls formwork and steel rear building 7 & 8 (Red)**

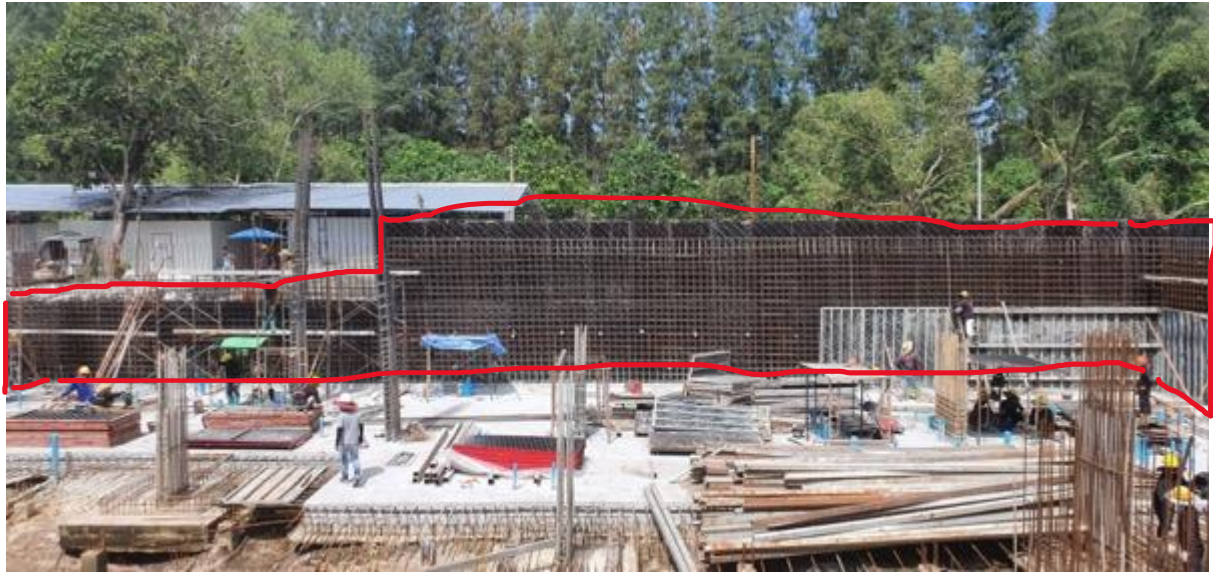
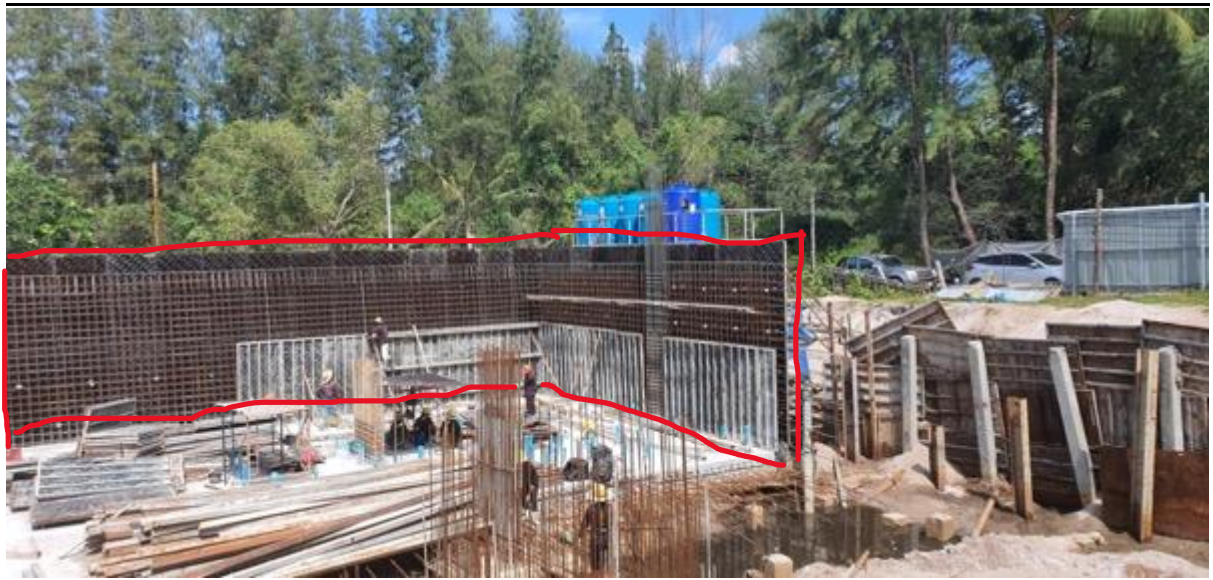
**Preparing formwork and steel rear of building 7 & 8 retaining walls (red)**  
**note height of pour was approximately 4M – scale is provided by workers**  
**size**
